# Manhole Inspection Summary

Manhole # S23I1\_001MH

Insp Date: **7/23/08 1:41 PM**

**Location** Address: **2727 Rittenhouse Rd**

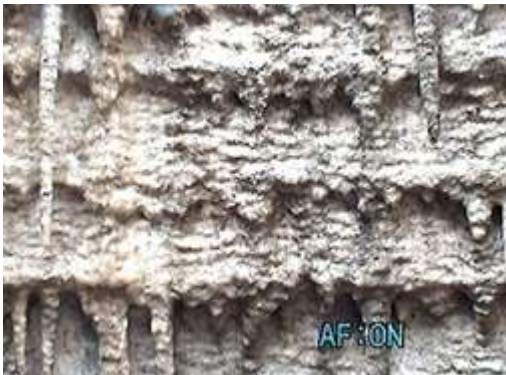
Miscellaneous

some kind of growth at chimney and corbel or could be parged

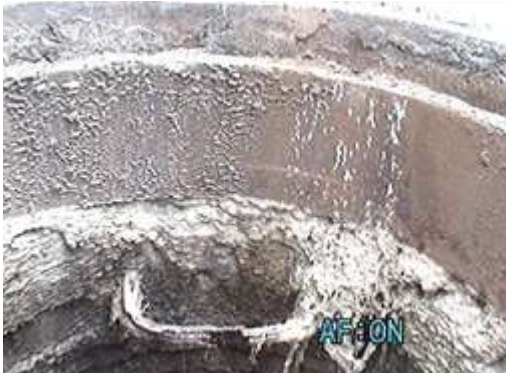
Defect 7

**Frame** Offset: **2** (in.) Condition: ☐ Sound ☐ Cracked ☒ **Leaks**

infiltration lid-frame

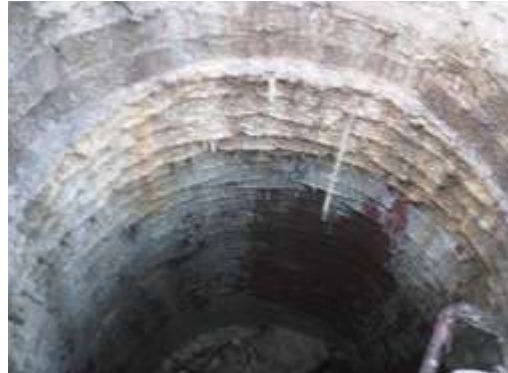
Defect 6

Condition: ☐ Sound ☐ Cracked ☐ Root Intrusion ☐ Loose Brick ☒ **Deteriorated**

kind of organic build up in chimney corbel

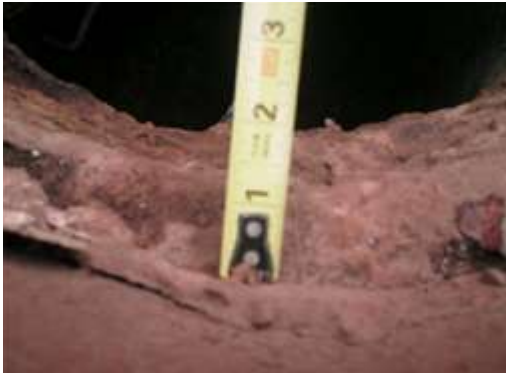
Defect 5

offset

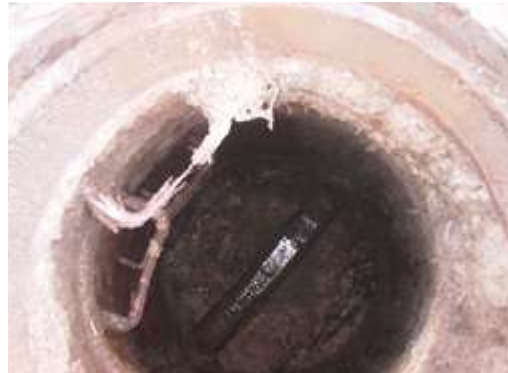
Defect 3

**Steps** Count: **7** Missing: **0** ☒ **Corroded**

corroded rungs

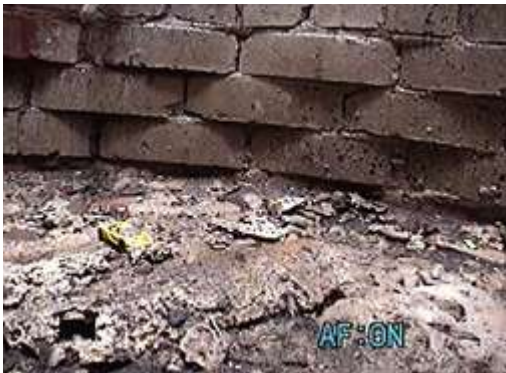
Defect 1

Condition: ☐ Sound ☐ Cracked ☐ Root Intrusion ☐ Deteriorated ☐ Leaks ☒ **Debris**

debris bench

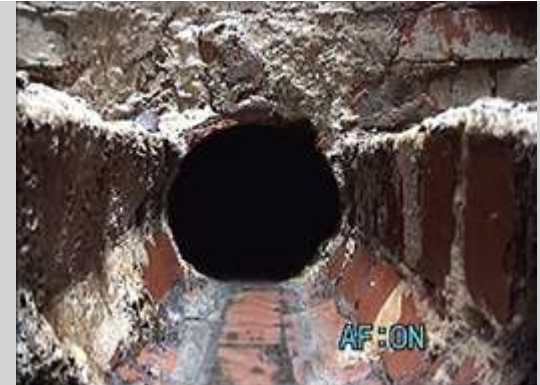
12 O'Clock Outflow

8 in. Circular Gravity Sewer  
Pipe Out @ 12 O'Clock

Pipe Height: **8.4** (in.) Rod and Bar (Angled)  
Pipe Material: **Clay** ☐ Pipe Lined  
Invert Depth: **10.63** (ft.) Flow Characteristics: **Fast**  
Deposits: ☒ None ☐ Mud ☐ Sludge ☐ Debris ☐ Grease  
Silt Depth: **0** (in.) Deposits Extent:  
Infiltration: **None** Pipe Seal Cond: **Sound**

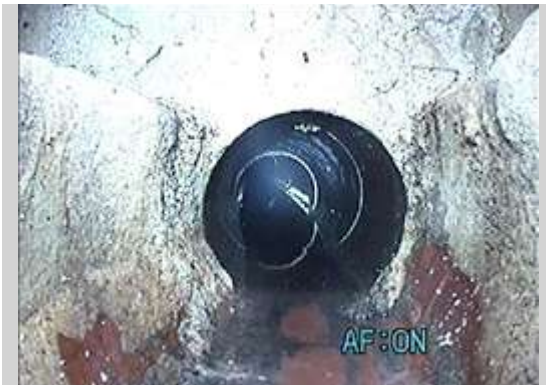
6 O'Clock Inflow

8 in. Circular Gravity Sewer  
Pipe In @ 6 O'Clock

Pipe Height: **8.4** (in.) Rod and Bar (Angled)  
Pipe Material: **Clay** ☐ Pipe Lined  
Invert Depth: **10.58** (ft.) Flow Characteristics: **Fast**  
Deposits: ☒ None ☐ Mud ☐ Sludge ☐ Debris ☐ Grease  
Silt Depth: **0** (in.) Deposits Extent:  
Infiltration: **None** Pipe Seal Cond: **Sound**
